CASE REPORT

A simple new technique for the removal of fractured femoral stems: a case report

Keywords: Cementless femoral stem, Stem breakage, Stem fracture, Revision surgery, Extraction

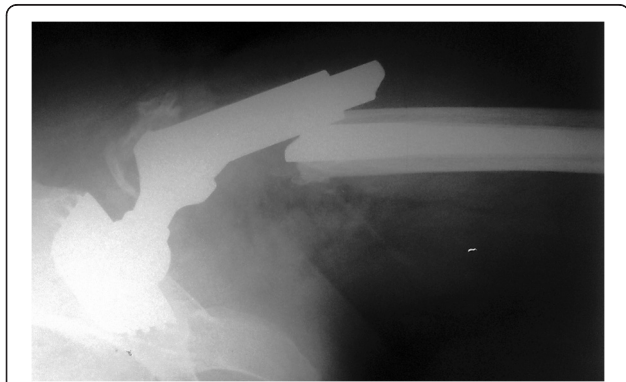
Figure 1 Plain radiograph of the fractured prosthesis.

Our patient was given spinal anesthesia, in the lateral decubitus position. We used the direct lateral approach that was extended distally. The fracture was 7cm distally from the tip of the greater trochanter, just at the junction of the proximal and distal modular parts and at the level of the remaining bone after the primary resection (Figure 1). The proximal part of the femoral stem was extracted easily and without complications. We continued with the disengagement of the proximal portion of the distal part of the femoral stem from the surrounding bone. We needed at least 2cm to have enough space for two locking pliers. This was achieved with a longitudinal osteotomy through the anterior cortex extending distally for 10cm (Figure 2A). The transversal osteotomy was 2cm below the tip of the femoral stump to allow enough space for two locking pliers. The transversal osteotomy was about 60 to 70 percent of the total bone circumference as shown (Figure 2B). A lamina spreader was then inserted in the osteotomy line proximally and two bone

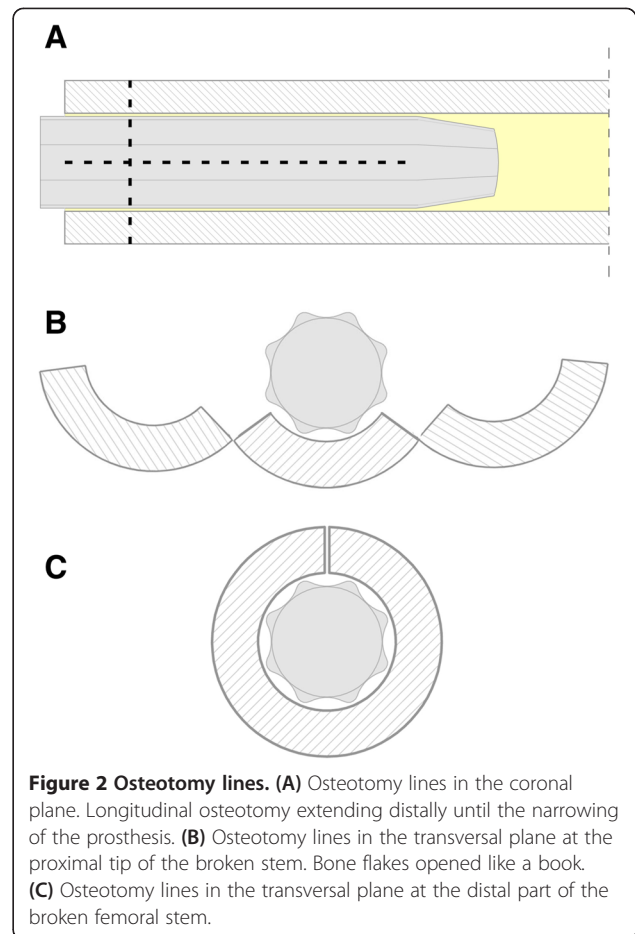
Figure 2 Osteotomy lines. (A) Osteotomy lines in the coronal plane. Longitudinal osteotomy extending distally until the narrowing of the prosthesis. (B) Osteotomy lines in the transversal plane at the proximal tip of the broken stem. Bone flakes opened like a book. (C) Osteotomy lines in the transversal plane at the distal part of the broken femoral stem.

flakes were opened like a book in order to provide space for the tip of the locking pliers (Figure 2B). The proximal tip of the broken stem was compressed as much as possible with two locking pliers. A lamina spreader was then inserted in the remaining distal longitudinal osteotomy and carefully opened for 1 to 2mm to allow the bone to separate from the stem, avoiding fracture of the femur (Figure 2C). Simultaneously, a hammer was used on the locking pliers and with several strong strokes the broken stem was removed from the bone easily (Figure 3). Next, a cerclage wire was inserted below the horizontal cut to prevent a possible uncontrolled fracture of the femoral bone during broaching. A second cerclage wire was inserted on the proximal 2cm of the femoral bone, which adapted perfectly. The femoral canal was reconstructed perfectly with minimal damage to the periosteum. The new revision prosthesis was then inserted in the standard manner (Figure 4).

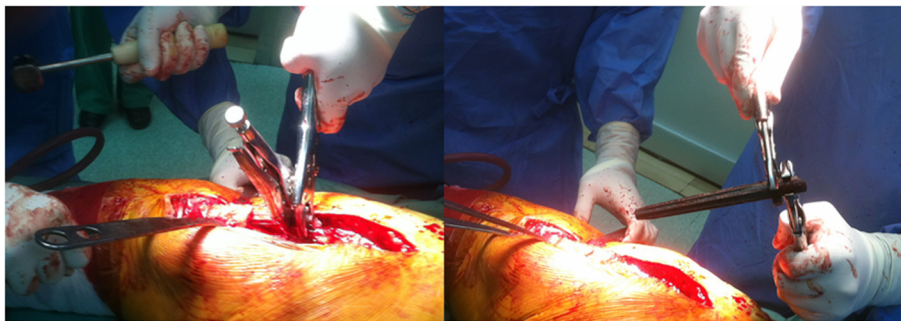
Figure 3 Intraoperative photographs.

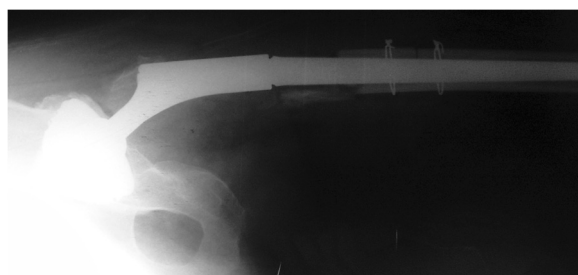
Figure 4 Postoperative plain radiograph. Note the excellent adaptation of the osteotomy lines.

excellent adaptation of the osteotomy line. Damage to the periosteum is only done during osteotomy through the anterior cortex and is minimized, which also promotes bone healing. Good fixation of the new revision prostheses can be made due to bone stock conservation and the excellent adaptation of the osteotomy line. This enables early mobilization and rehabilitation of the patient, minimizing the postoperative complications.
